Manhole Inspection Summary

Manhole # S23K__043MH

Insp Date: **6/10/08 3:33 PM**

Location Address: **1409-200 S Norris St**

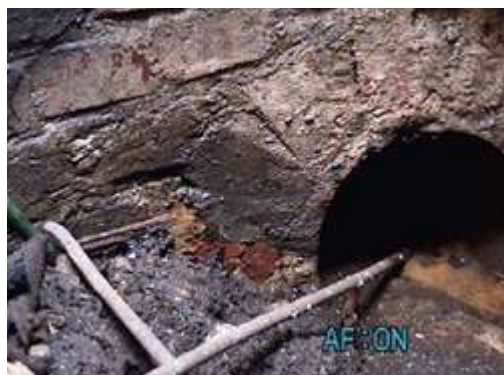
Defect 4

Infiltration: ☐ None ☐ Joint ☐ Cracks ☒ **Mortar** ☐ Roots ☒ **Wall**

barrel infiltration at mortar/wall

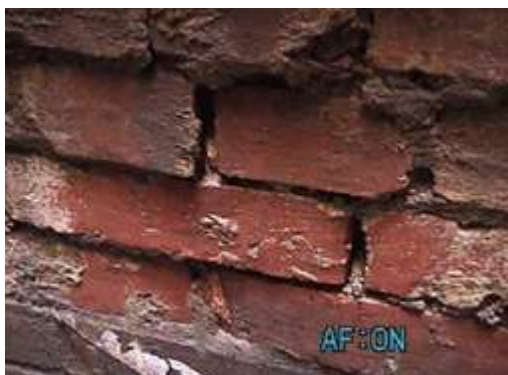
Defect 2

Condition: ☐ Sound ☐ Cracked ☐ Root Intrusion ☒ **Loose Brick** ☐ Deteriorated

barrel loose bricks

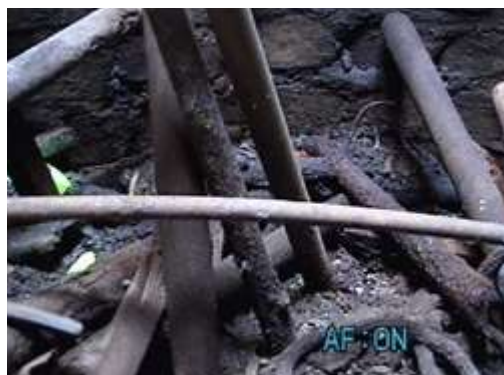
Defect 1

Condition: ☐ Sound ☐ Cracked ☐ Root Intrusion ☐ Deteriorated ☐ Leaks ☒ **Debris**

channel debris

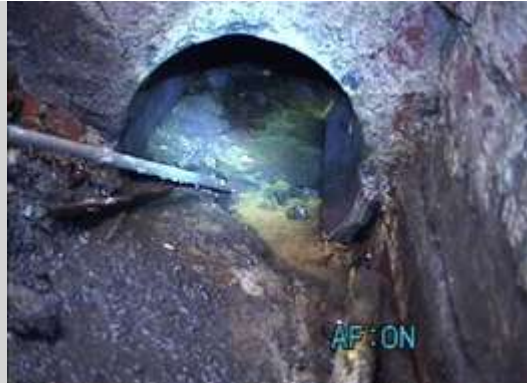
12 O'Clock Outflow

8 in. Circular Gravity Sewer
Pipe Out @ 12 O'Clock

Deposits: ☒ None ☐ Mud ☐ Sludge ☐ Debris ☐ Grease

Infiltration: **None** Pipe Seal Cond: **Sound**
